Nomination for Waters  
Important to Anadromous Fish

Anadromous Water Catalog Number of Waterway 221-60-11350

Name of Waterway Allison Creek ☐ USGS Name ☐ Local Name

**From:** Dennis Gnath [DGNATH@jpo.doi.gov]  
**Sent:** Thursday, August 07, 2003 7:47 AM  
**To:** ed\_weiss@dnr.state.ak.us  
**Cc:** al\_ott@dnr.state.ak.us  
**Subject:** Fwd: Email 1--7-29-03 Allison Creek DW Weir Washout-Salmon inand above Weir before repair

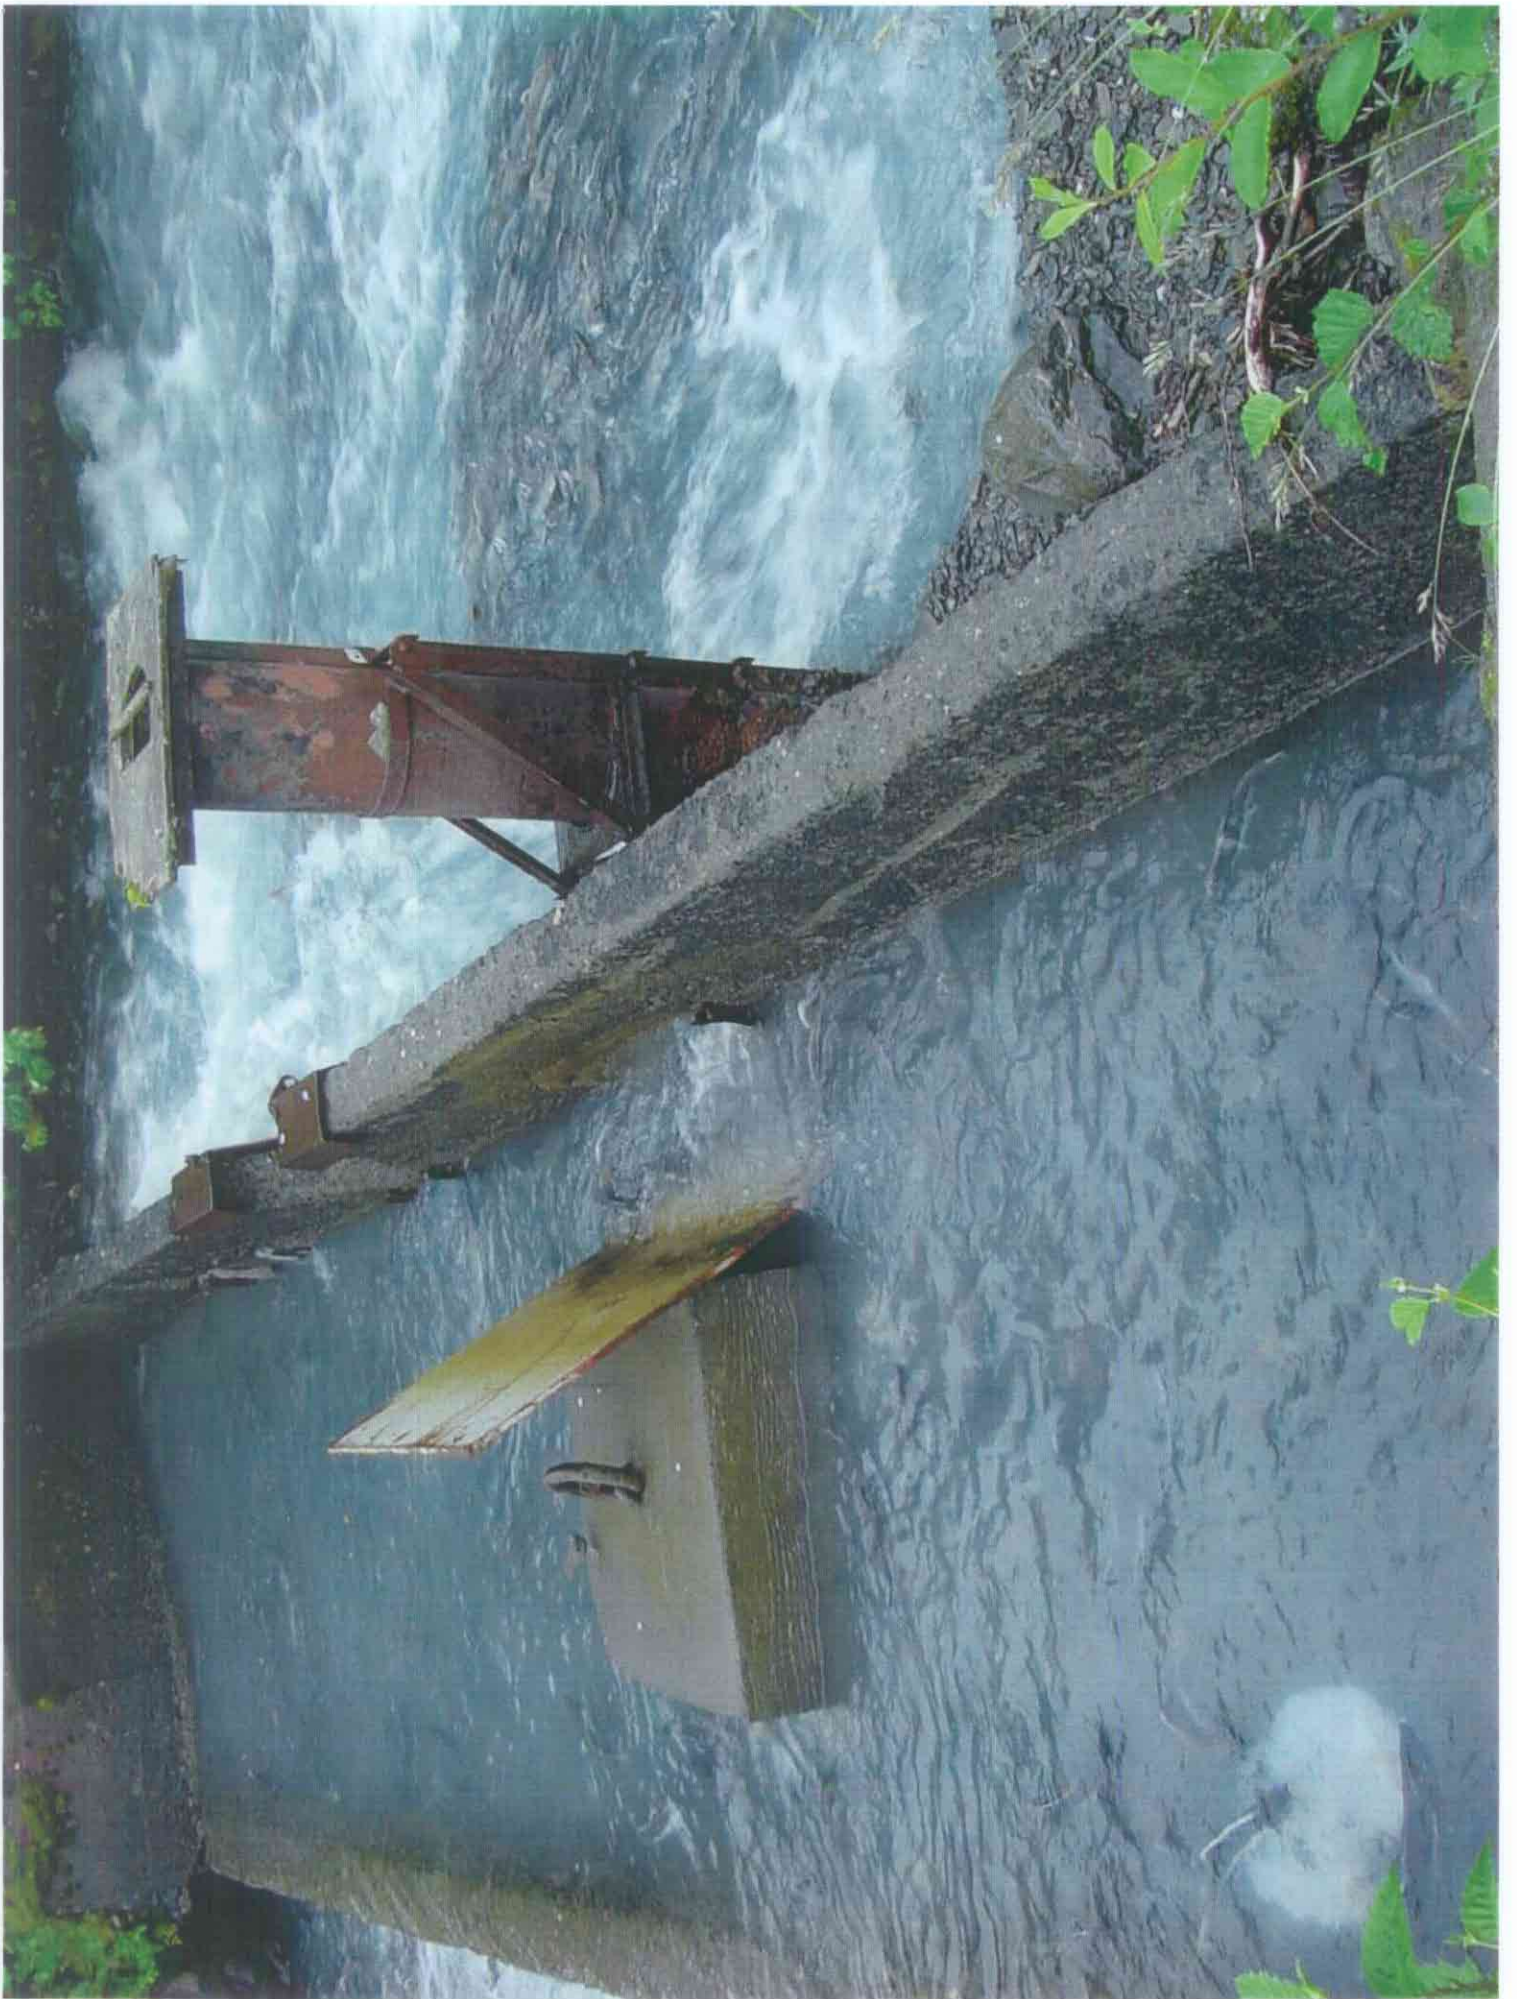
7\_29\_03 Pic 1 Allison Creek DW Weir Washout-Salmon in and above Weir before repair--Alyeska Pic 7-29a.JPG;

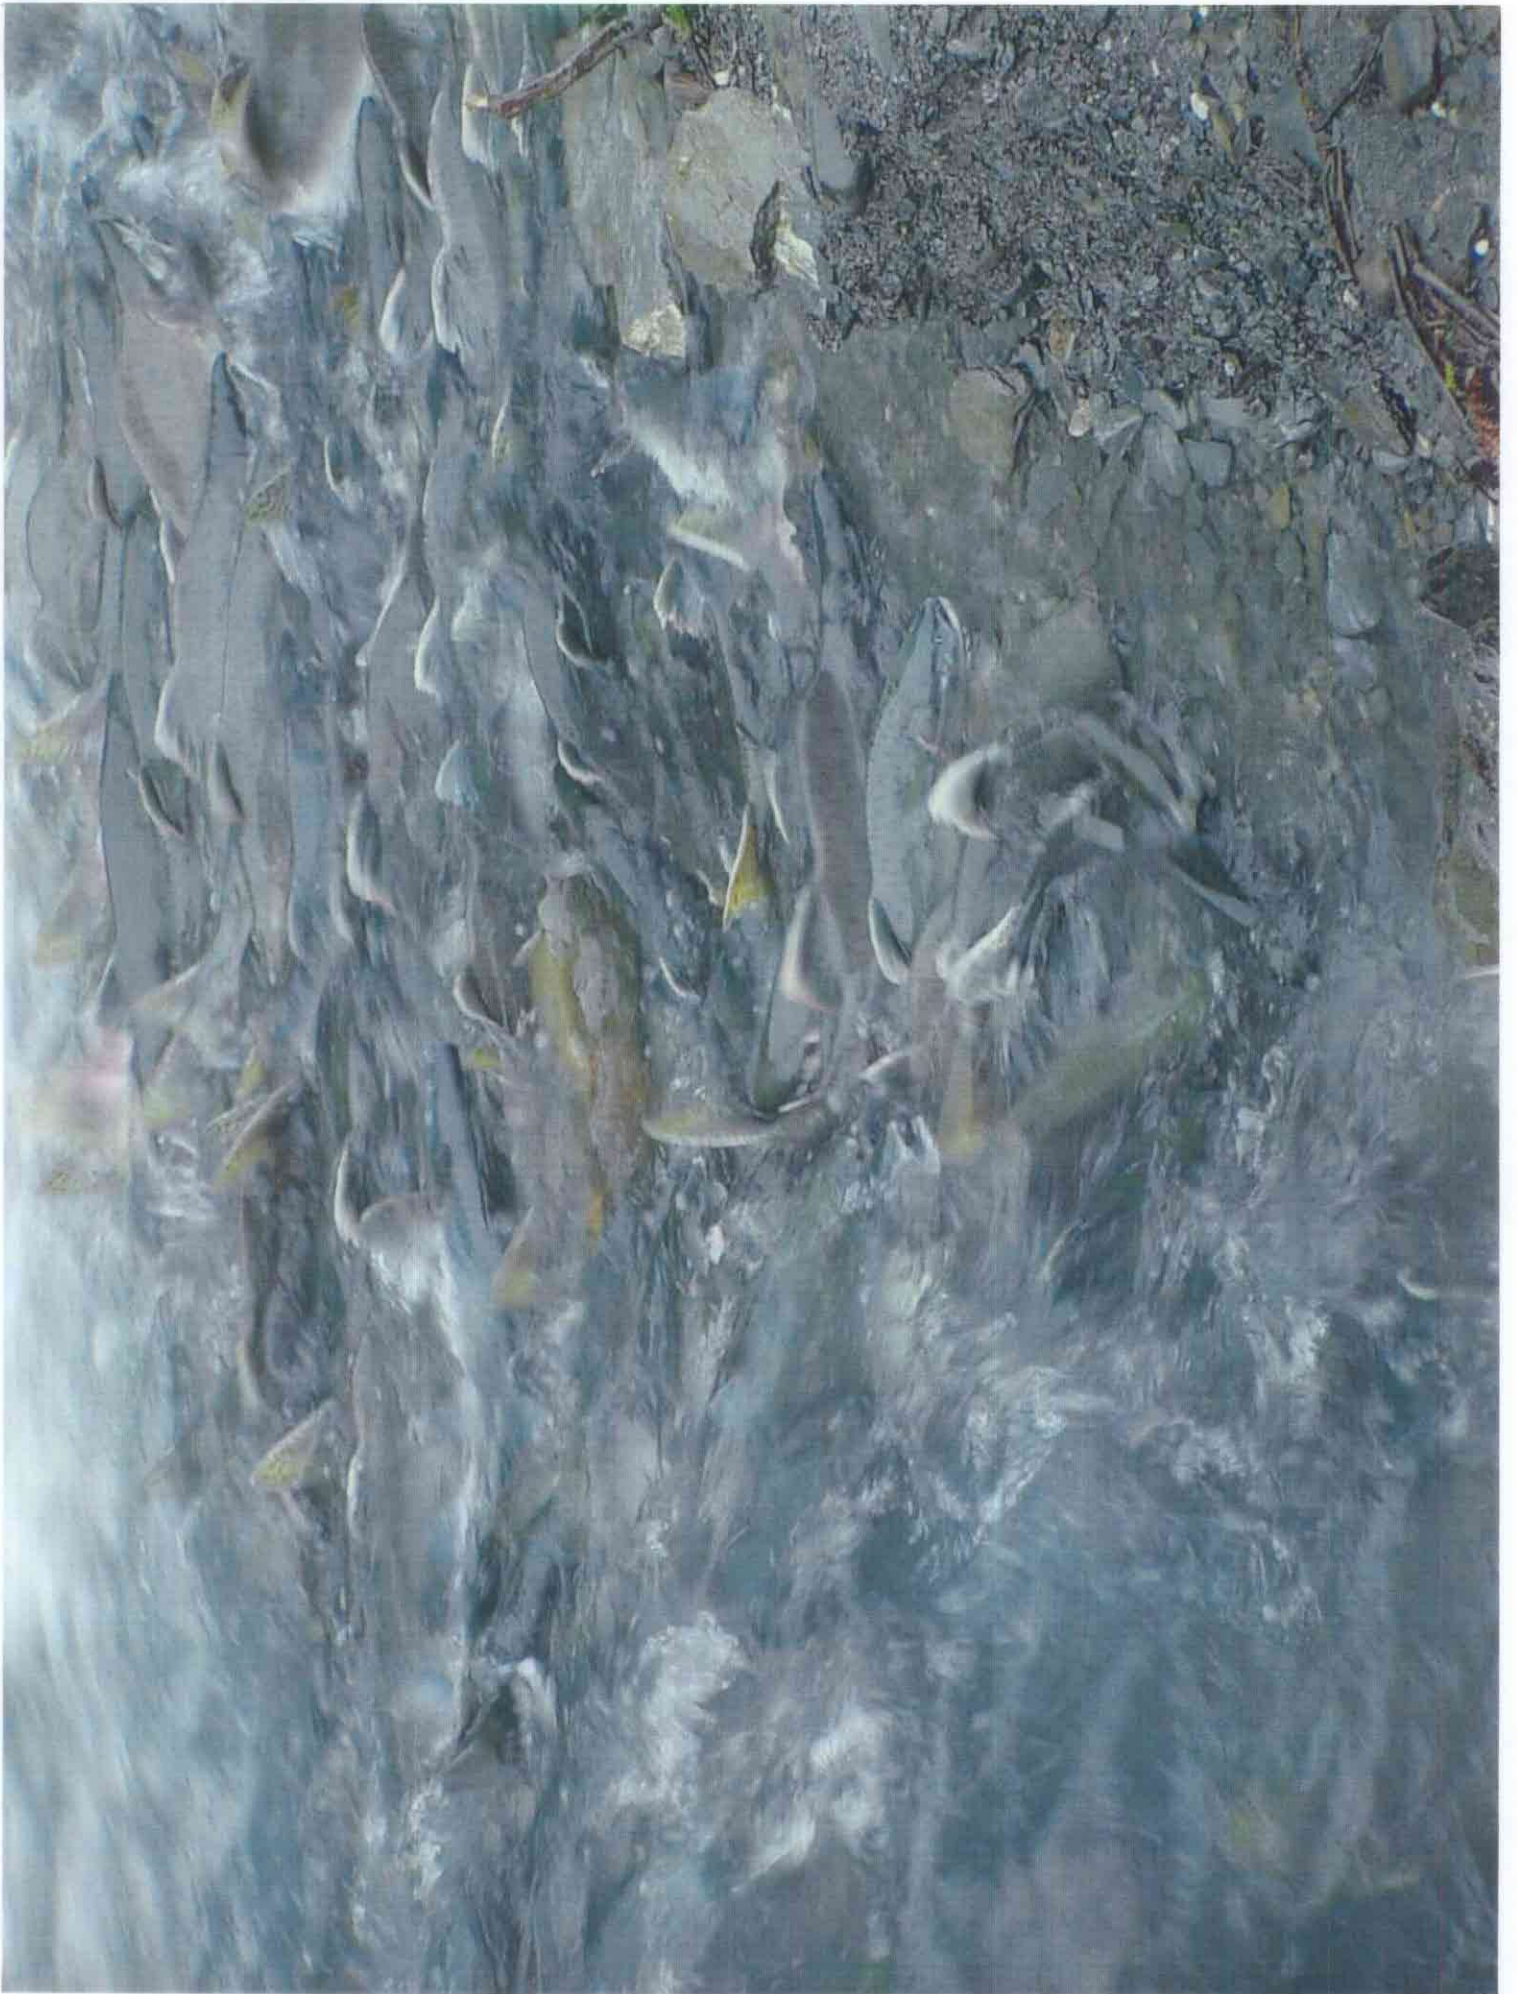
7\_29\_03 Pic 2 Allison Creek DW Weir Washout-Salmon above Weir before repair--Alyeska Pic 7-29b.JPG;

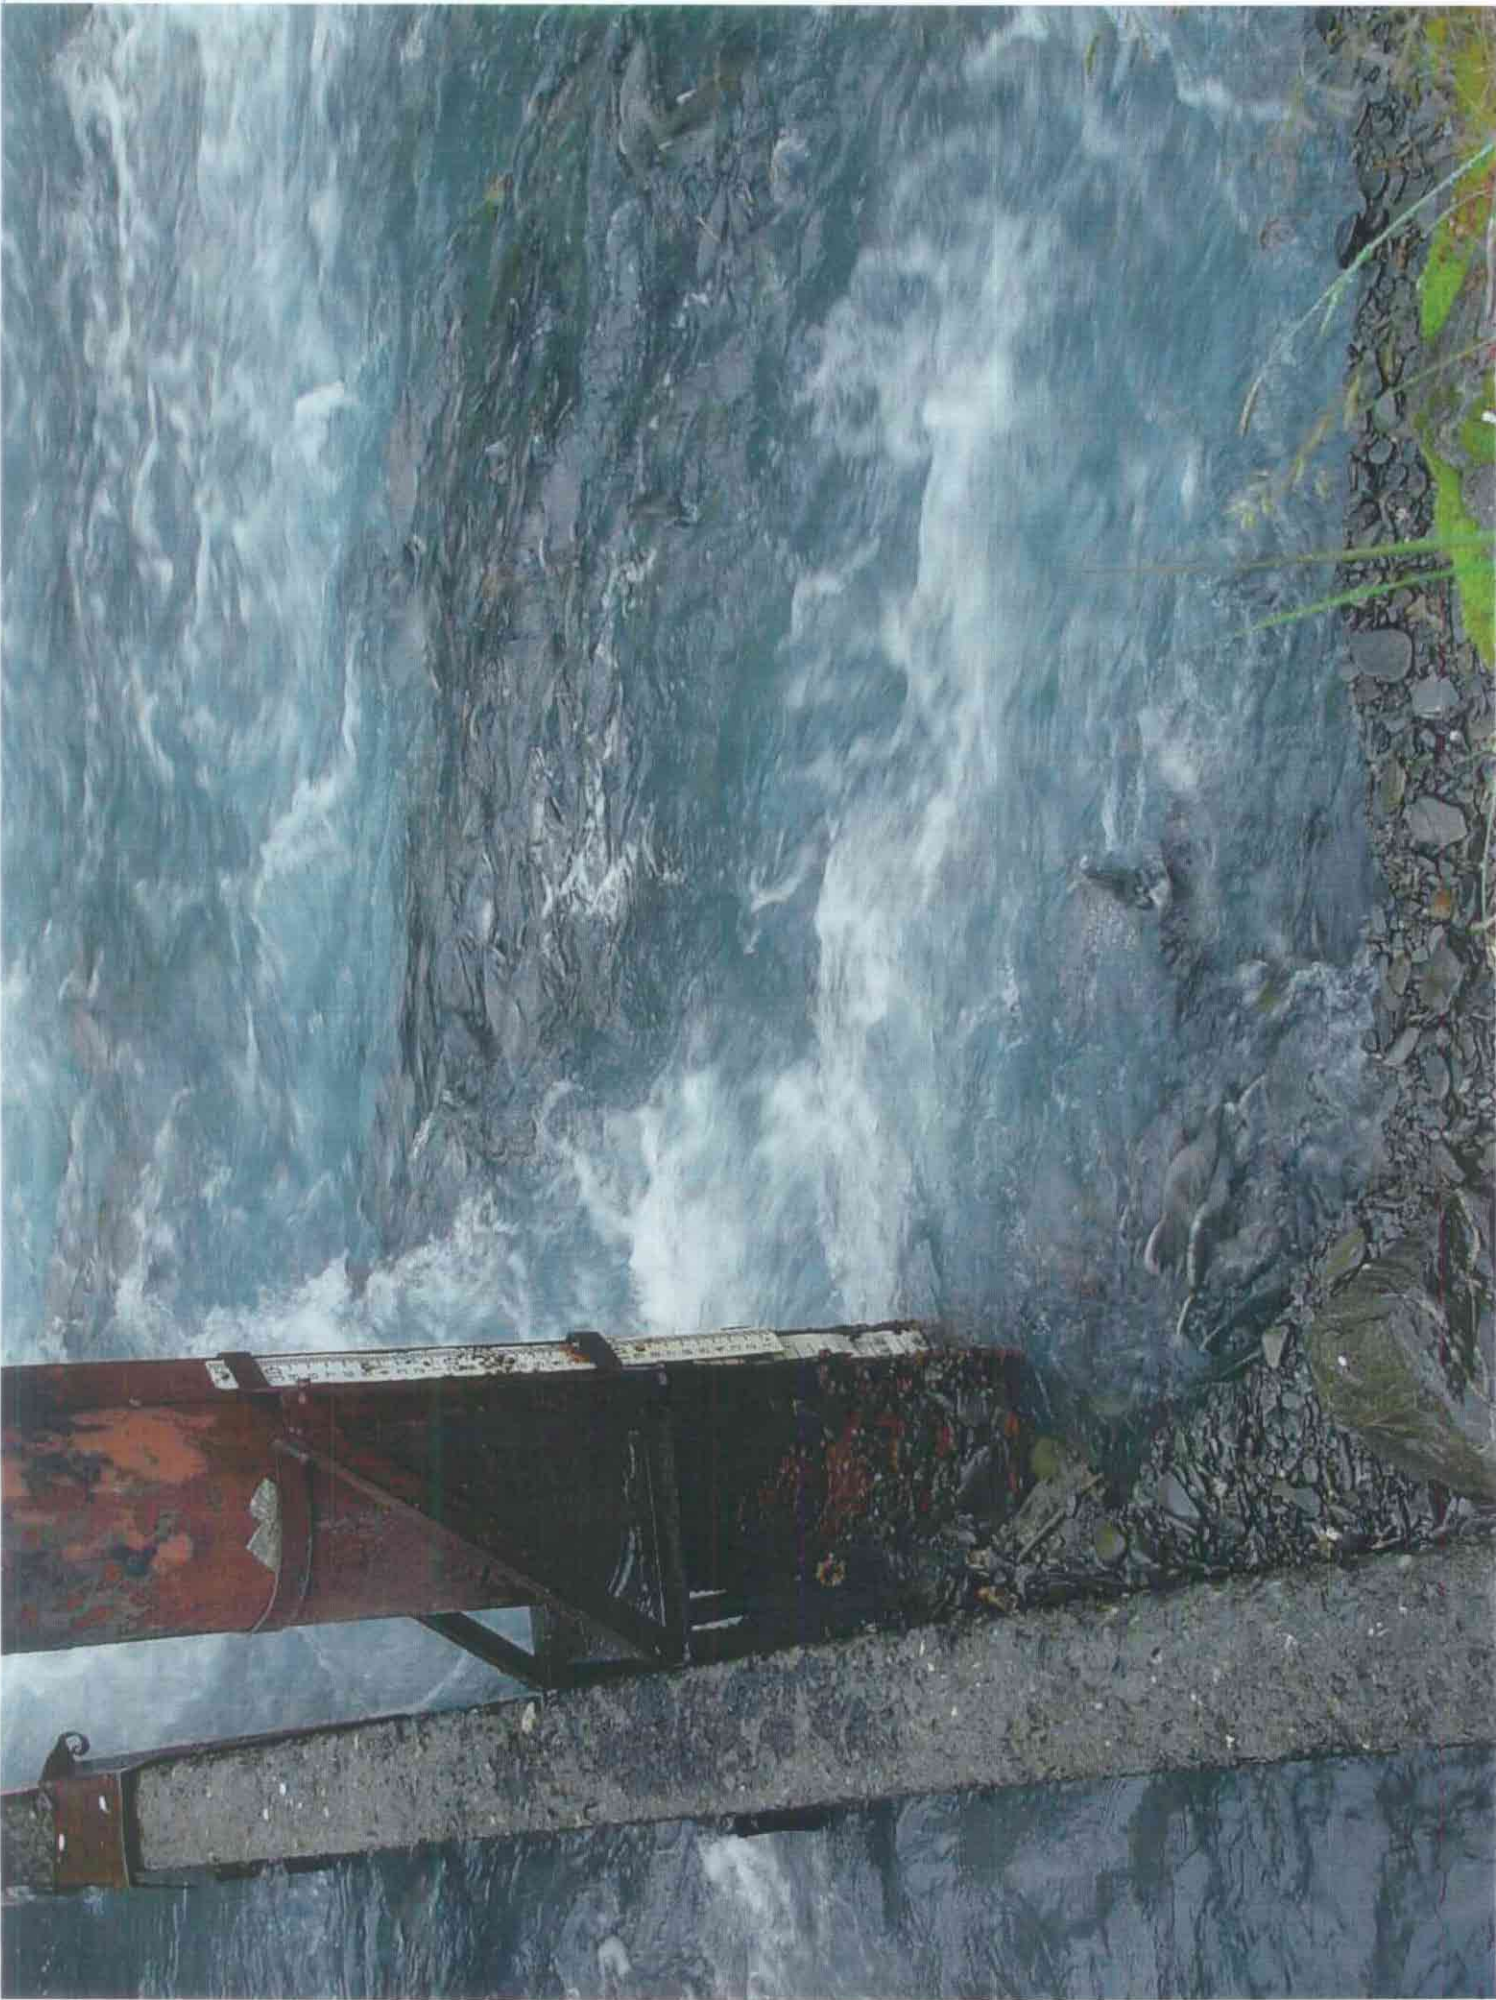
7\_29\_03 Pic 3 Allison Creek DW Weir Washout-Salmon above Weir before repair--Alyeska Pic 7-29c.JPG;

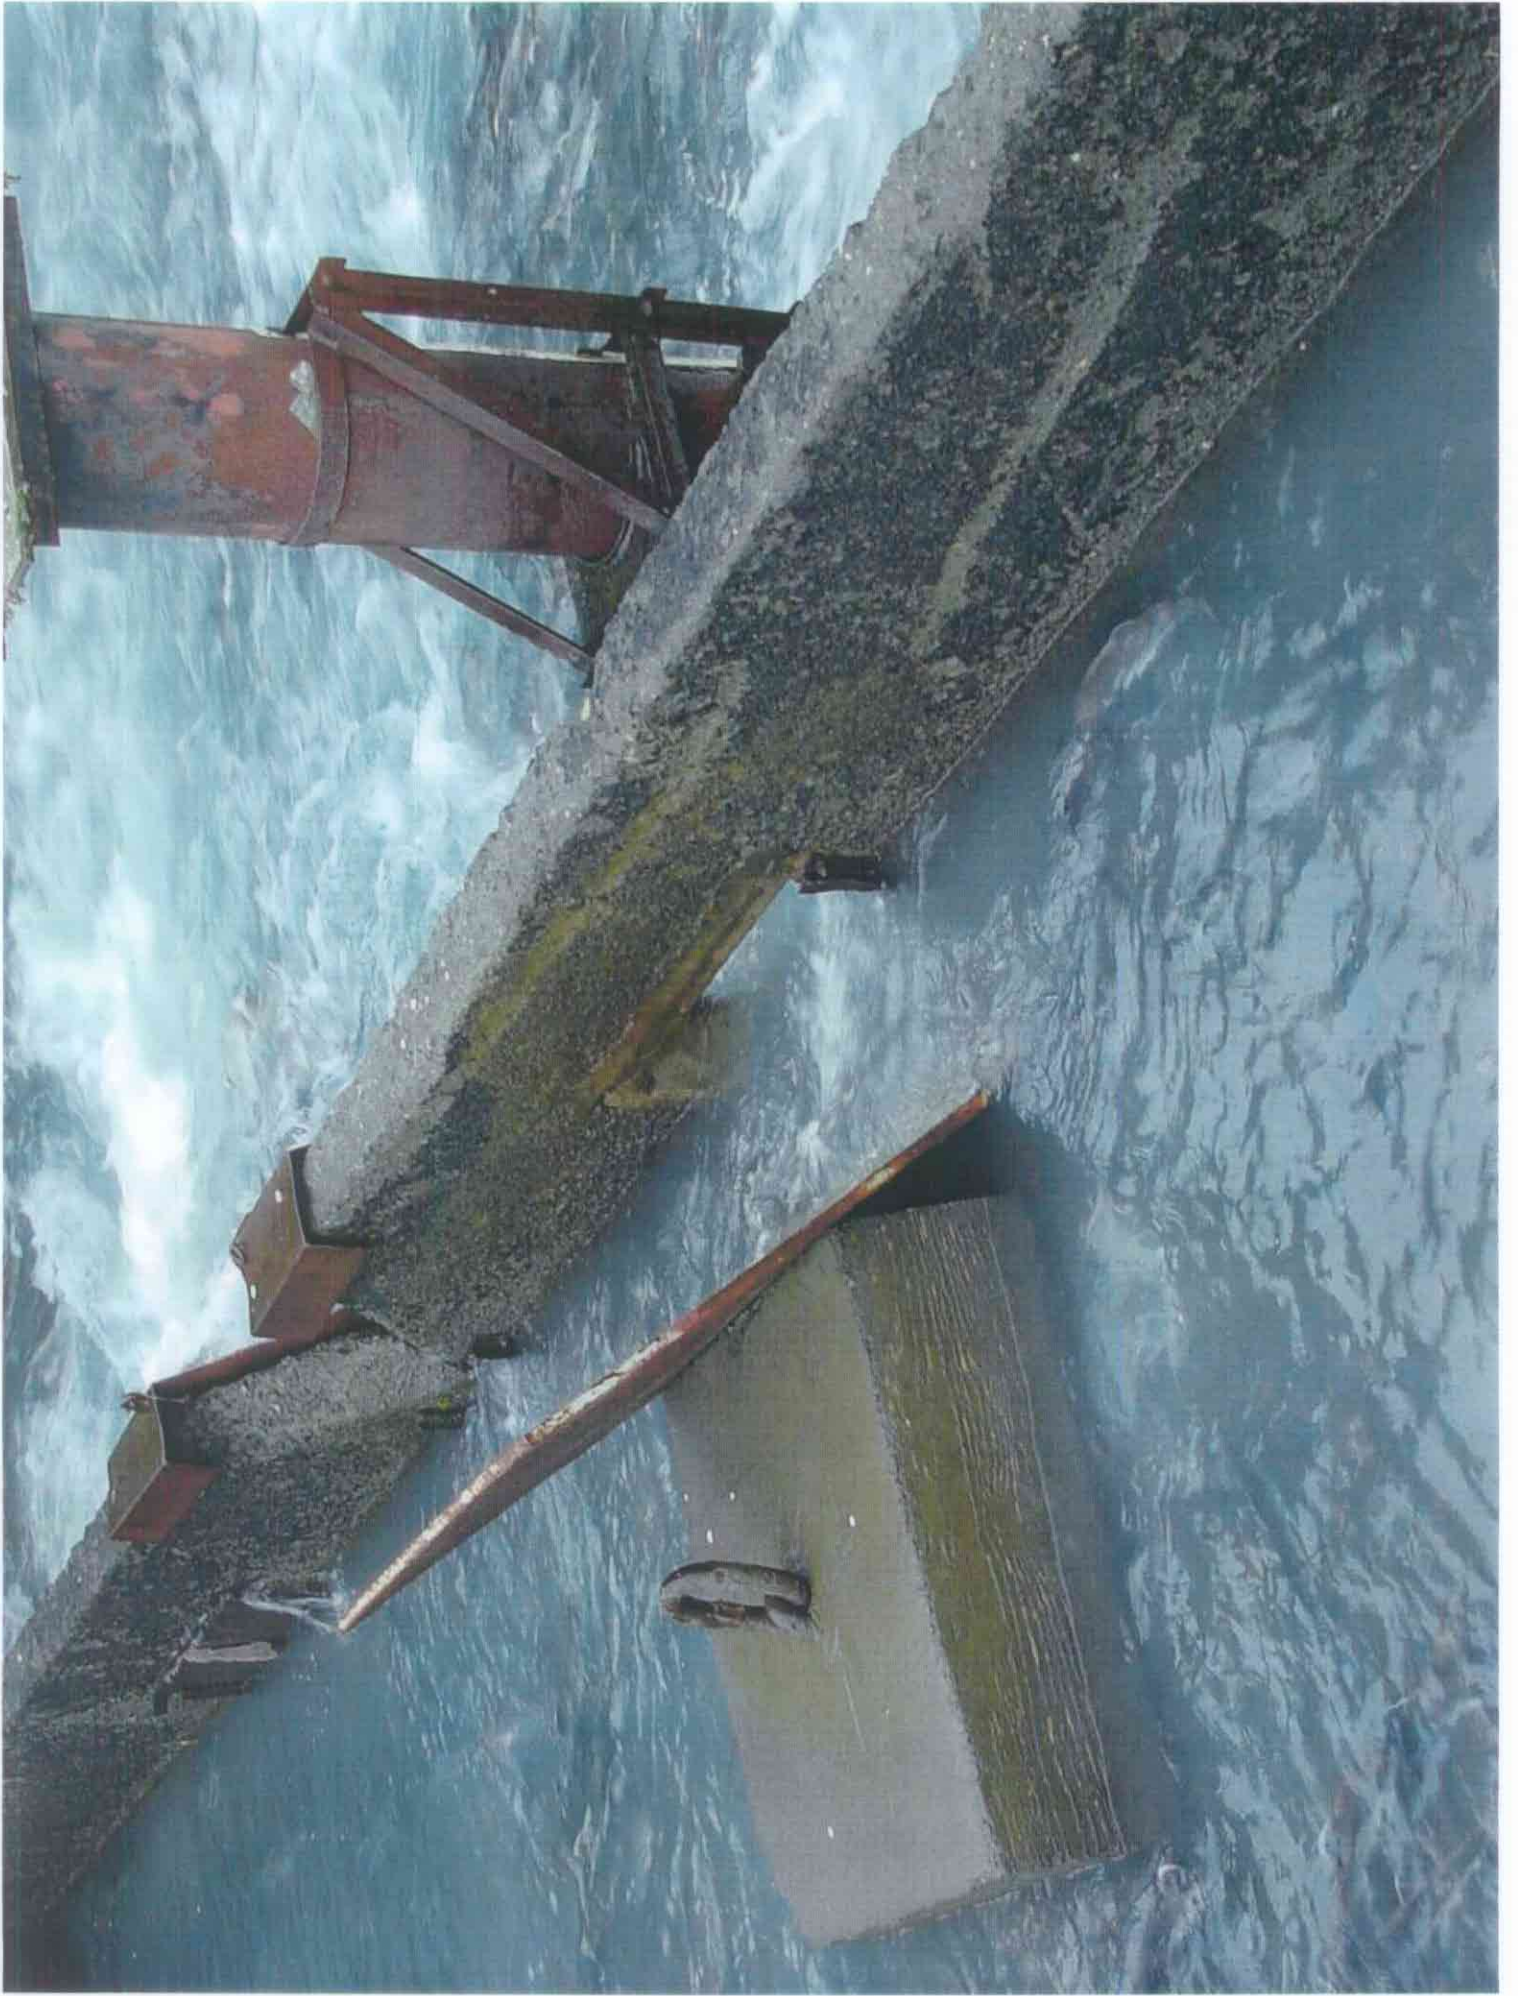
7\_29\_03 Pic 4 Allison Creek DW Weir Washout-Salmon in Weir before repair--Alyeska Pic 7-29d.JPG;

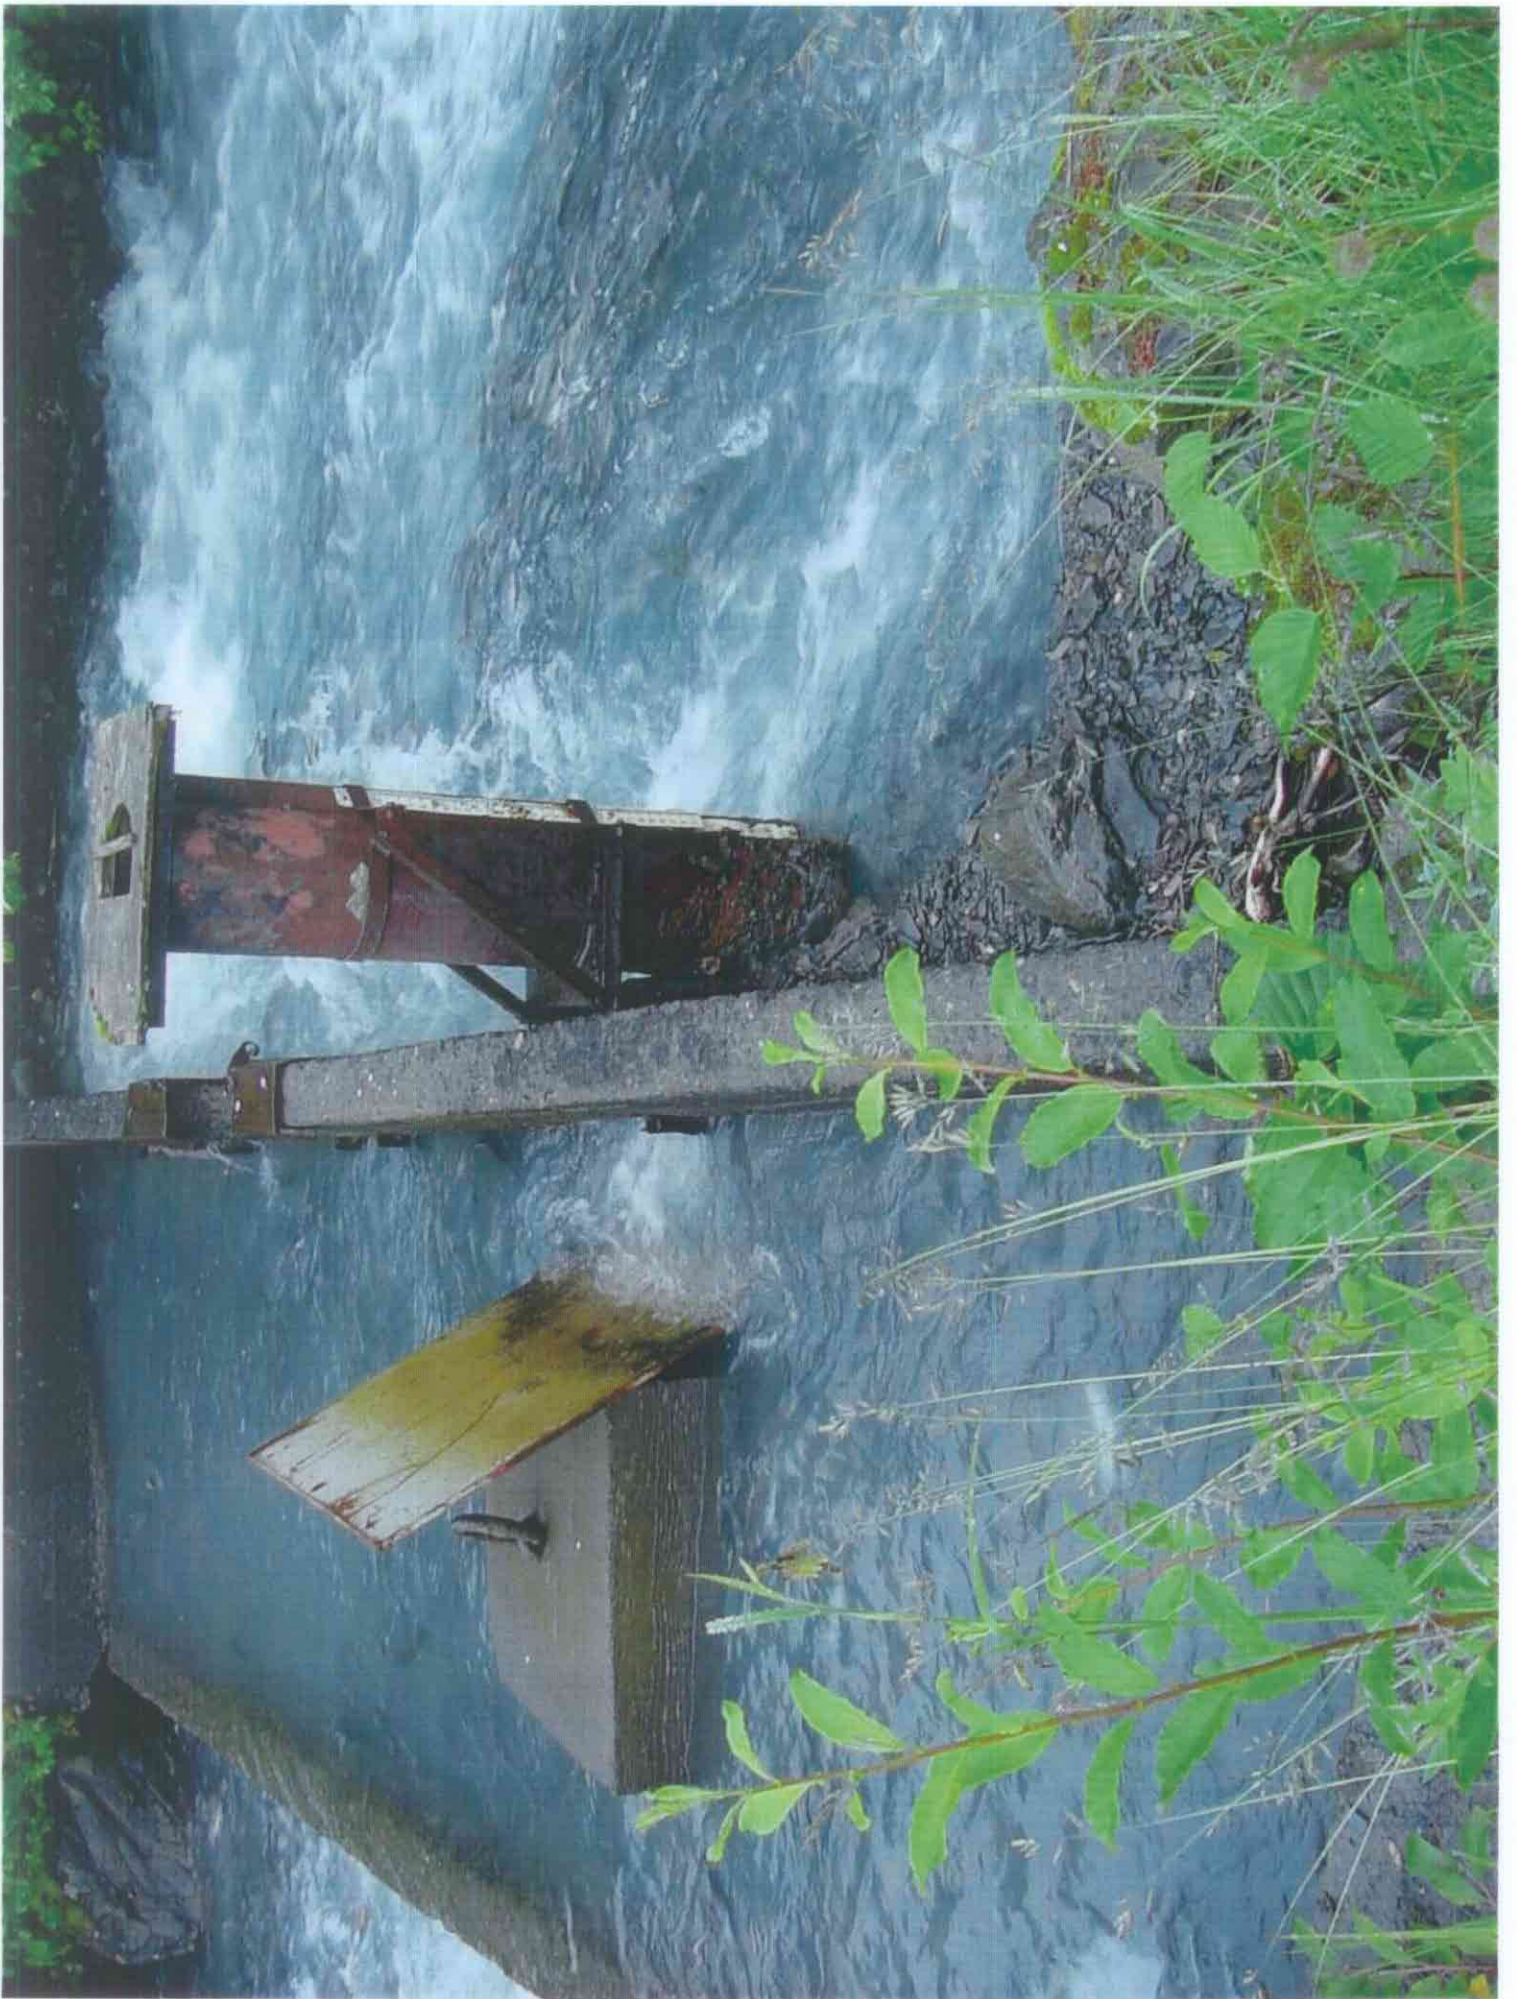
7\_29\_03 Pic 5 Allison Creek DW Weir Washout-Salmon in and above Weir before repair--Alyeska Pic 7-29e.JPG;

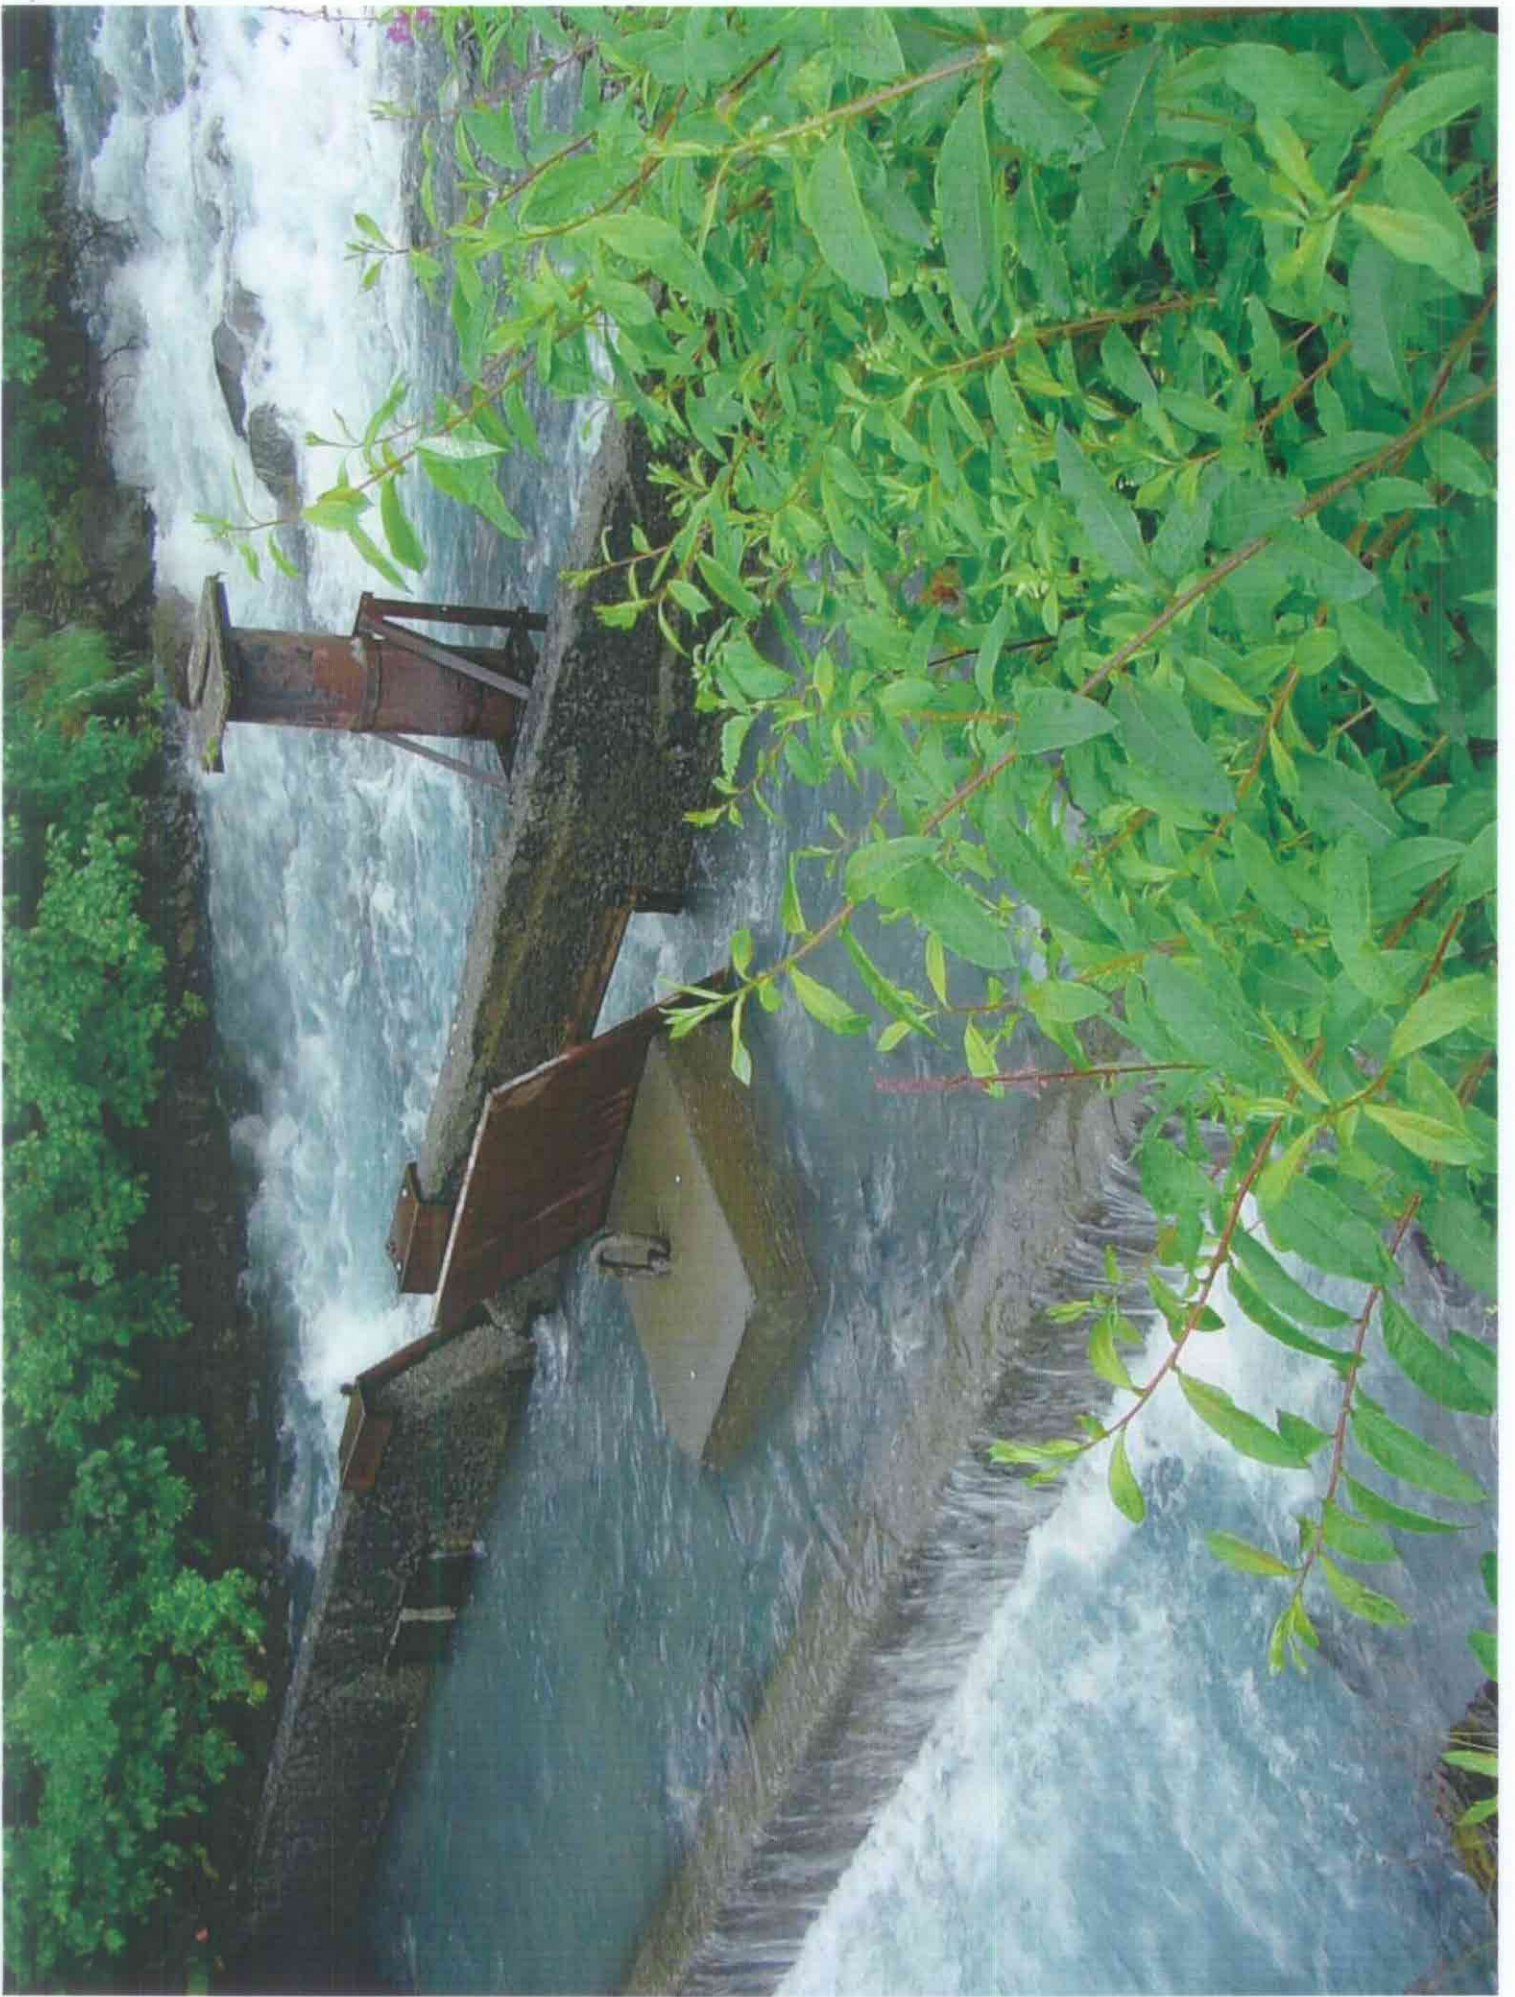
7\_29\_03 Pic 6 Allison Creek DW Weir Washout-Salmon in and above Weir before repair--Alyeska Pic 7-29f.JPG;

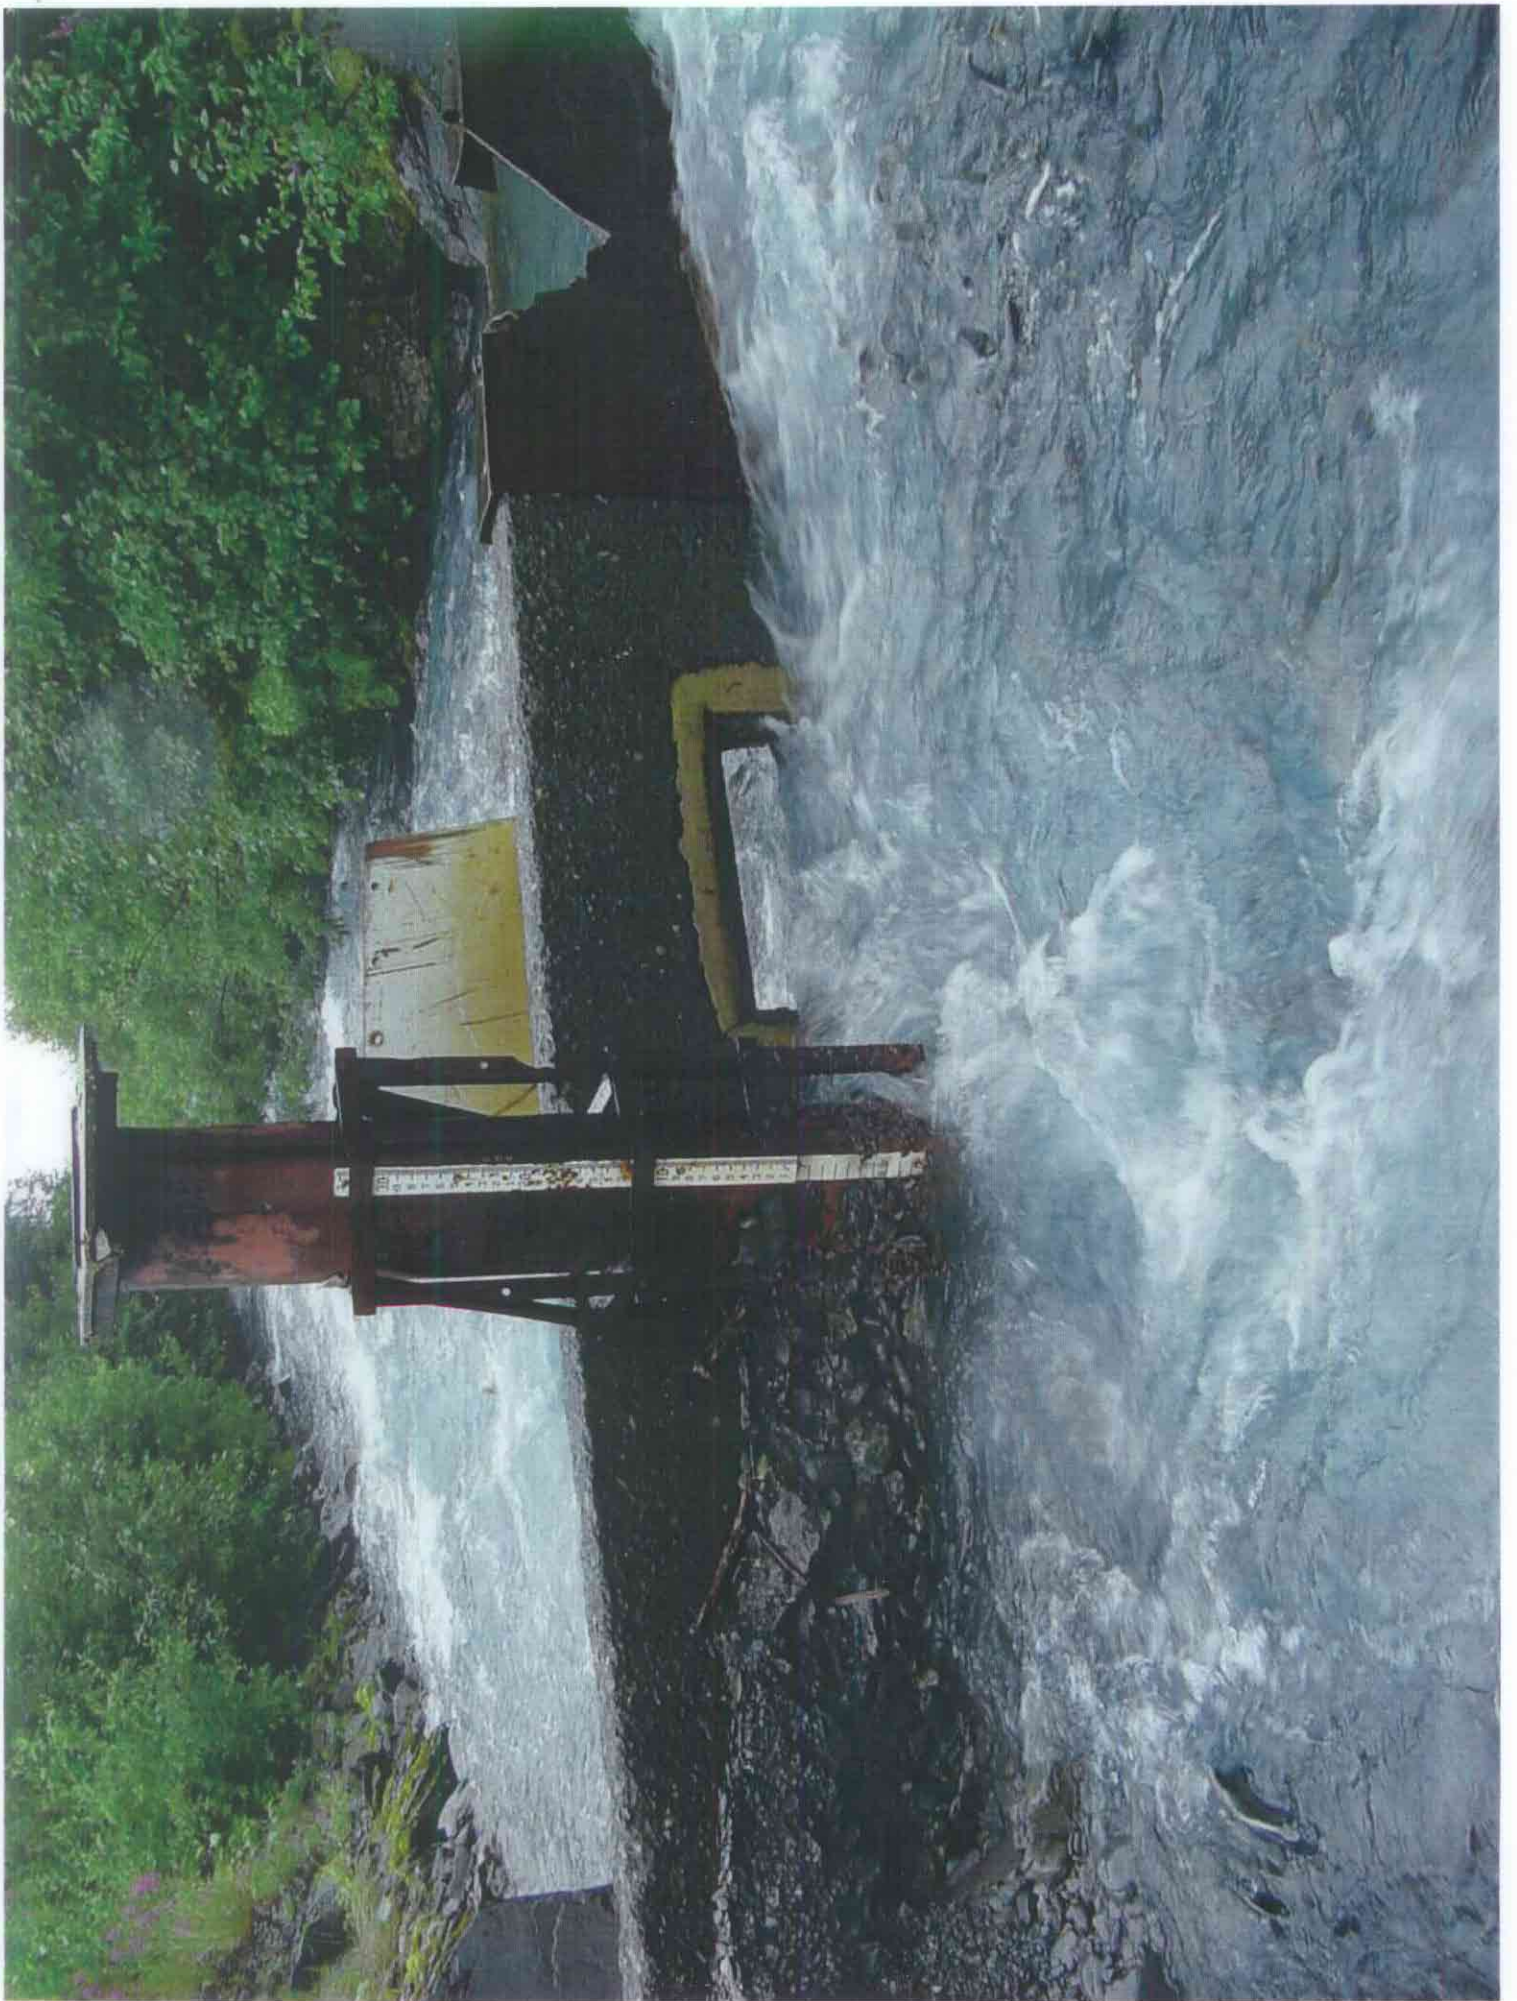
7\_29\_03 Pic 7 Allison Creek DW Weir Washout-Salmon above Weir before repair--Alyeska Pic 7-29g.JPG;
